NATIONAL ADVISORY COMMITTEE FOR AERONAUTICS

TECHNICAL NOTE

No. 1603

APPLICATION OF STATISTICAL METHODS TO STUDY OF GAS-TURBINE BLADE FAILURES

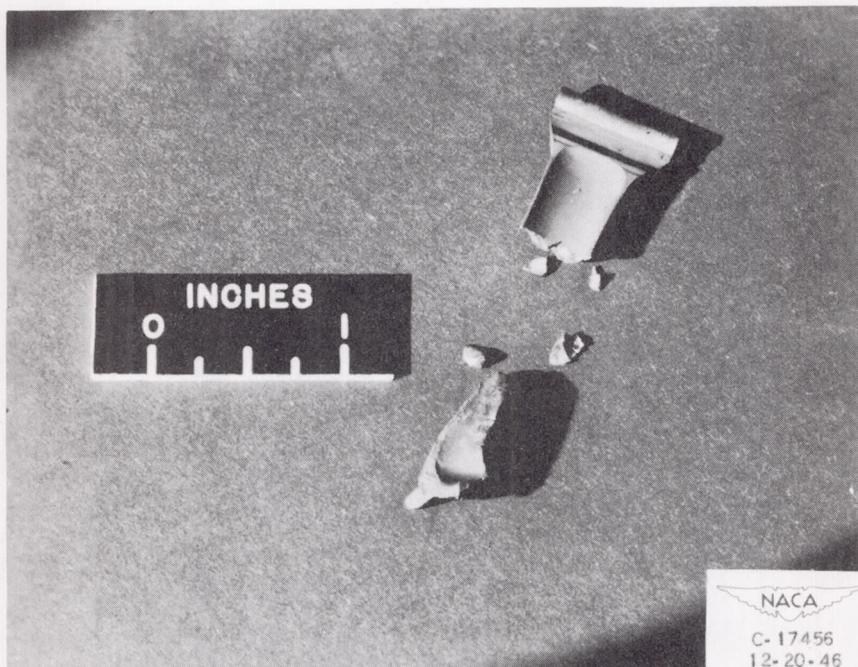
The appearance of wheel 1 after a total of $28\frac{1}{2}$ hours of power and condition time is shown in figure 3(a). The blade-root portion and fragments from wheel 1 after a total of $28\frac{1}{2}$ hours of power and condition time are shown in figure 3(b). These photographs are

of the wheel during initial runs revealed that a few blades were badly cracked (figure 3(a)). The assumption was therefore made that these cracked blades would fail very soon and removal of blades which had cracks longer than half the blade width would speed the program by lengthening the interval between wheel removals. The criterion of failure of the material was therefore considered to be fracture or severe cracking. The number of failures recorded during a given time period was the total of all replaced. Operation in this manner was found to allow periods of operation as long as 5.4 hours without shutdown for overhaul. At shutdown as many as nine fractured blades and as many as 13 cracked blades were replaced. The use of these data in the plotting of distribution curves was found to be difficult. The time interval chosen for plotting the frequency-distribution curve was necessarily large because the length of time between shutdowns was very large. The use of time intervals less than the length of time between shutdowns occasionally resulted in time intervals with a frequency of zero. An unsuccessful attempt was made to adjust the data of the cracked blades to approach more closely their actual fracture times. The data of the completely fractured blades were studied to determine the average time elapsed between a severe crack and a complete fracture, but these elapsed times had a very wide range and a reliable correction factor could not be determined. In addition, the exact time when a given amount of cracking occurred was impossible to determine.

(a) Turbine wheel showing cracked and fractured blades.

Figure 3. - Damage to blades of wheel I after $28\frac{1}{2}$ hours of power and condition time.

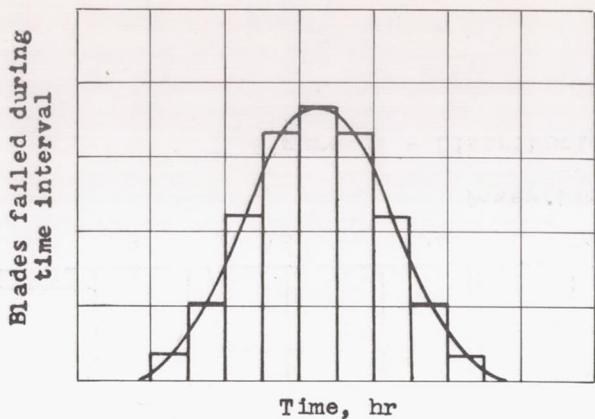
representative of the failures experienced with the exception of one blade that exhibited local necking. The damaged condition of the fragments thrown from the wheel is the result of the impact of the fragments upon the water-cooled drum.

(b) Fragments of fractured blades.

Figure 3. - Concluded. Damage to blades of wheel I after $28\frac{1}{2}$ hours of power and condition time.

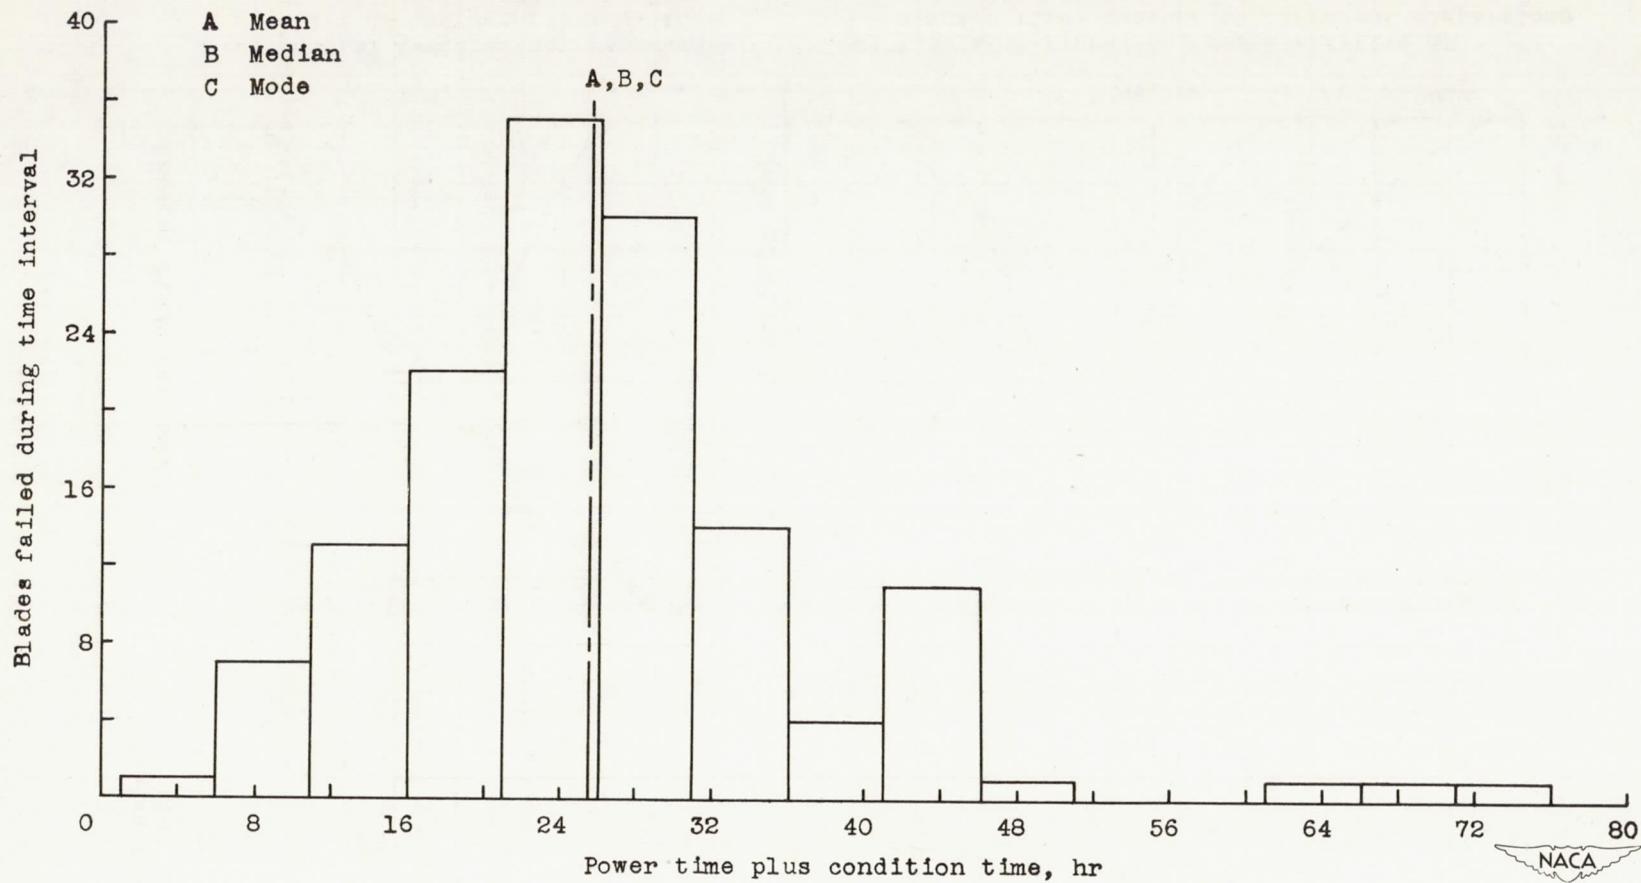
Figure 5. - Distribution of time to blade failure for wheel 1.

Wheel 1. - The failures for wheels 1 and 2 are summarized in tables I and II, respectively. The blade failures experienced appeared to be of the stress-rupture type, in combination with other effects. The distribution of blade failures for wheel 1 are shown in figure 5. The abscissa is the total of power and condition times

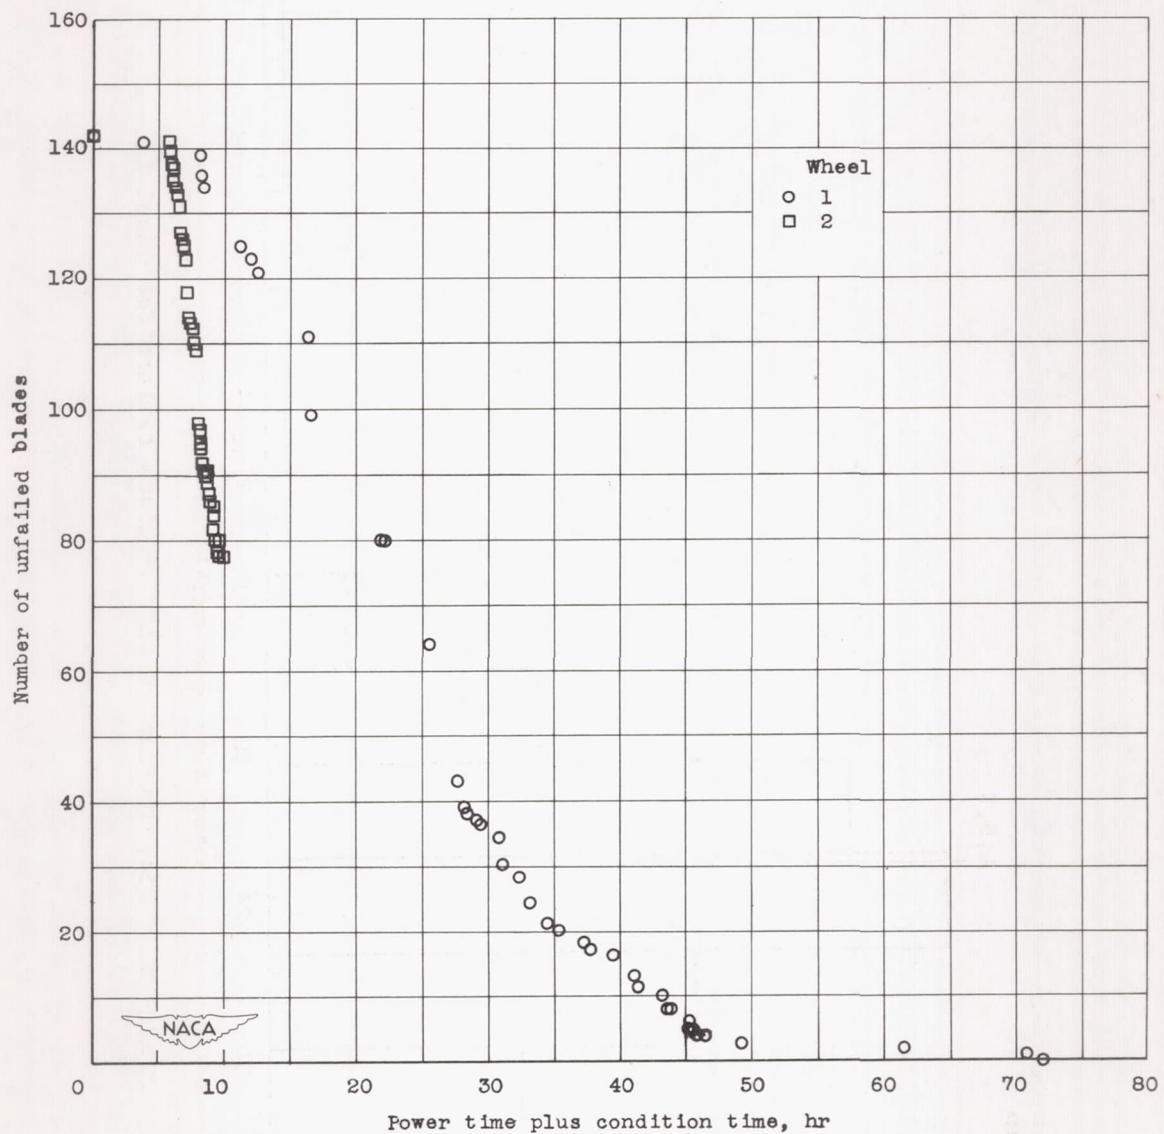
Figure 6. - Cumulative-frequency curves of time for blade failures.

377
wheel 1 occurred after 3.92 hours and the first of wheel 2 after 5.59 hours. If the wheels are compared on this basis, the probable life of wheel 2 is indicated as being 43 percent greater than that of wheel 1. The error in this conclusion may be seen by comparing the materials by means of a cumulative-frequency curve (fig. 6), which is a plot of total blades surviving against running time. The life of the average blade of wheel 2 is suggested as less than that of wheel 1, contrary to the analysis suggested by consideration only of initial failures. Although the blades in wheel 2 had heavier shrouds and consequently were more highly stressed, the time of initial failure of the wheel was greater than that of wheel 1, and the possible error resulting from the use of initial failure is thereby emphasized.
